## Trimble® Infrastructure GNSS Series Receivers

These release notes describe the latest improvements made to the Trimble® Infrastructure GNSS series receivers.

With this release, these products can now use version 4.85 firmware.

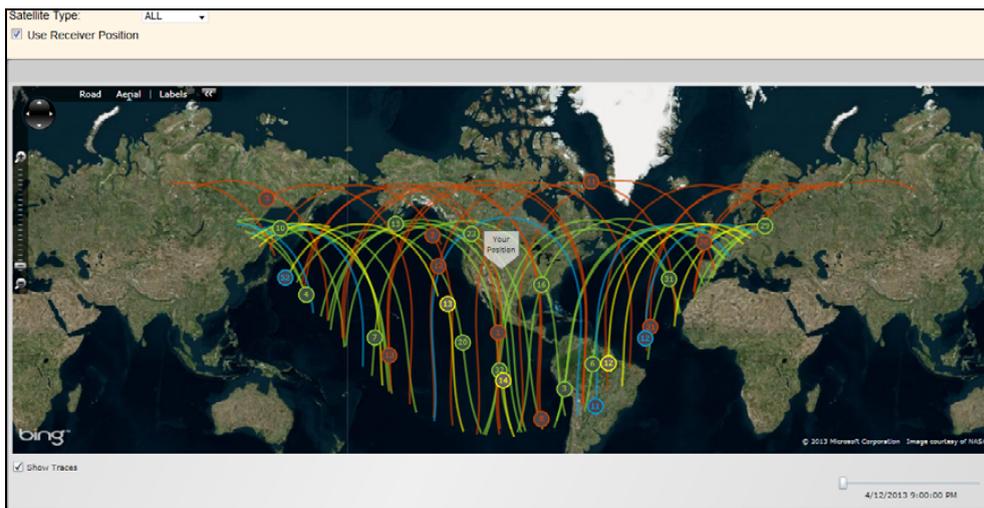
- Satellites - Map View

- A user can now specify the data time out period when to stop propagating corrections forward.
- New Web Interface menu, *Web Services*, that allows for the following selections:

In order to use the Web Services, the receiver must have an Internet connection and the device/browser connecting to the receiver must have the Microsoft® Silverlight® development tool (or variant thereof) installed.
